**Flood Control Project Maintenance  
Levee Inspections**  
**LMA District Cover Sheet**  
**Spring 2017 Levee Inspection Results**

**Reclamation District No. 0999 Netherlands**

**Spring 2017 Levee Inspection Results**

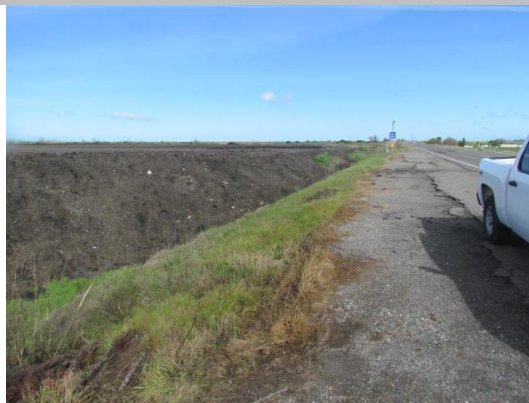
Photo 1 of 5 : SP\_2017\_RD0999\_232\_1\_20170314\_00001.jpg

Looking west at filled on waterward berm (spring 2016)

LM Start	0.12	Rating **	U	Issue No.	1 (cont)	
LM End	0.39	Issue Type +	En	Location *	WS	
Category	Earthen Levee			GPS Latitude/Longitude		
				Start	End	
Item	Encroachments			38.503346 °	38.499389 °	
				-121.582116 °	-121.581933 °	
DWR ID	DWR_RD0999_01_s_2012_1					
Comment Code						
MA : Material						
Inspector Comment						
Landfill has been in place for several years. Landowner is hauling additional material on waterward berm.

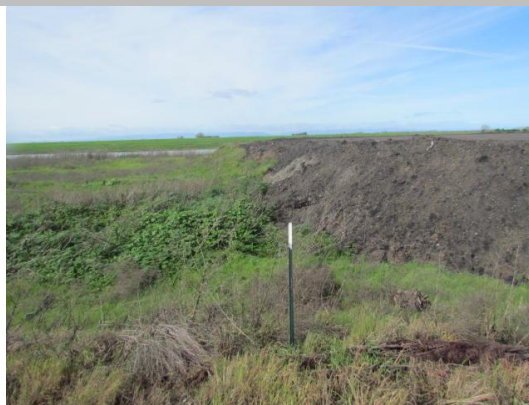
Photo 2 of 5 : SP\_2017\_RD0999\_232\_1\_20170314\_00002.jpg

Looking west at filled on waterward berm. (spring 2016)

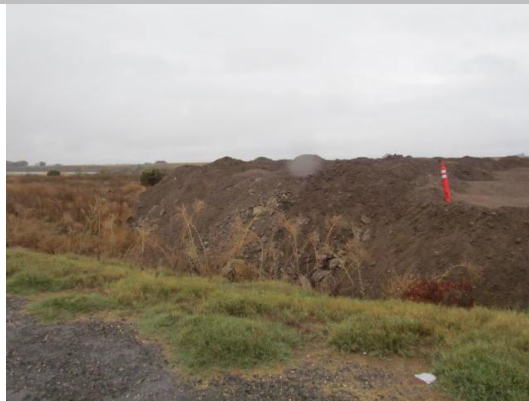
Photo 3 of 5 : SP\_2017\_RD0999\_232\_1\_20170314\_00003.jpg

Looking west at the end of new fill on waterward berm fall 2015.

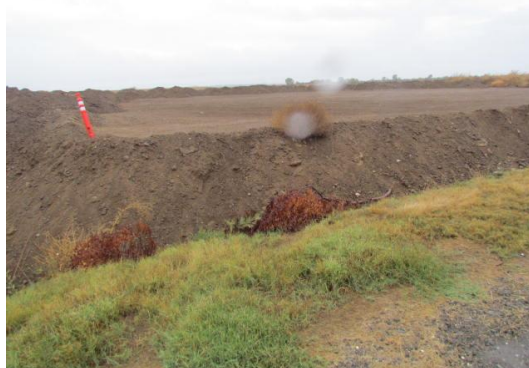
Photo 4 of 5 : SP\_2017\_RD0999\_232\_1\_20170314\_00004.jpg

Looking west at new fill on waterward berm fall 2015.

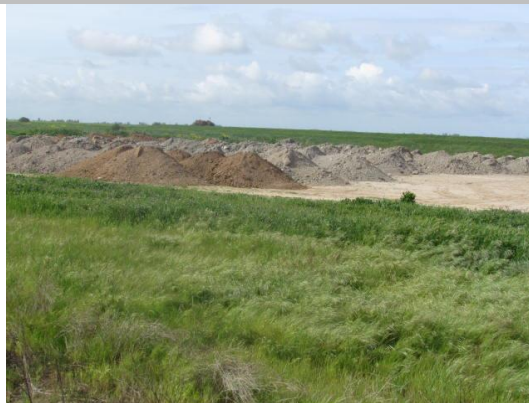
Photo 5 of 5 : SP\_2017\_RD0999\_232\_1\_20170314\_00005.jpg

Looking west at new material on waterward berm.

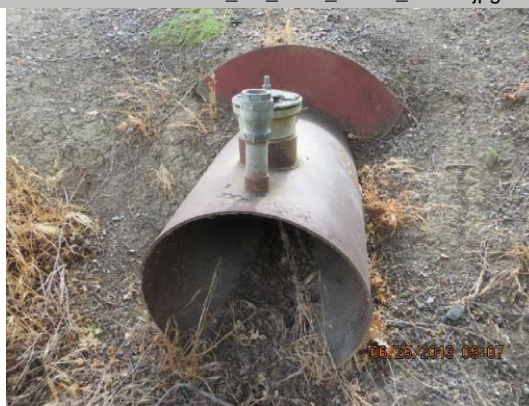
Photo 1 of 3 : UCIP\_SP\_2017\_50092\_25191.jpg

FS\_ID:50092  
DS\_ID:22743  
EP\_NO: N/A  
Repair Type: Urgent  
Crossing Status: Found  
UCIP Comments: 07/07/2016 Condition largely unchanged from previous inspection. Pipe open on the WS, waterward of the siphon breaker. Dense vegetation and steep slope limited inspection of WS outlet into Ship Channel. (T. Hatch/UCIP)  
06/25/2013 Pipe abandoned and open on WS slope. Pipe should be abandoned properly. (W. Wylie/UCIP)  
FIELD\_STRUCT\_DESC: \*ABANDONED\* 30-inch steel pipe through the levee, 6.5 feet below the crown. Pump on a platform in the canal off of the landside (LS) toe, not found. Flap gate on the waterside (WS), not found. Siphon breaker and an air vent on the WS shoulder. 1-inch galvanized iron filler pipe visible on the WS shoulder along same alignment. [Additional Reference(s): DWR Levee Log, 1992. USACE Sacramento O&M Manual 113 (Revised), October 1966 (LM 1.73)].  
FS Date: 7/7/2016

Pipe open on WS slope

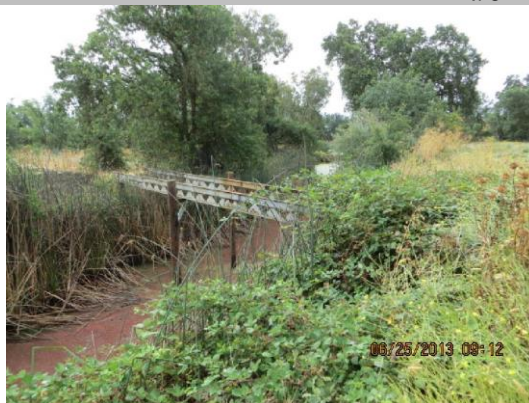
Photo 3 of 3 : UCIP\_SP\_2017\_50092\_25189.jpg

Item	DWR UCIP LMA Responsibility			38.480097 °	38.480097 °	
				-121.580844 °	-121.580844 °	
DWR ID						
Comment Code						
Inspector Comment						
FS_ID:50092 DS_ID:22743 EP_NO: N/A Repair Type: Urgent Crossing Status: Found UCIP Comments: 07/07/2016 Condition largely unchanged from previous inspection. Pipe open on the WS, waterward of the siphon breaker. Dense vegetation and steep slope limited inspection of WS outlet into Ship Channel. (T. Hatch/UCIP) 06/25/2013 Pipe abandoned and open on WS slope. Pipe should be abandoned properly. (W. Wylie/UCIP) FIELD_STRUCT_DESC: *ABANDONED* 30-inch steel pipe through the levee, 6.5 feet below the crown. Pump on a platform in the canal off of the landside (LS) toe, not found. Flap gate on the waterside (WS), not found. Siphon breaker and an air vent on the WS shoulder. 1-inch galvanized iron filler pipe visible on the WS shoulder along same alignment. [Additional Reference(s): DWR Levee Log, 1992. USACE Sacramento O&M Manual 113 (Revised), October 1966 (LM 1.73)]. FS Date: 7/7/2016

Pump platform visible off LS toe, but no appurtenances remain.

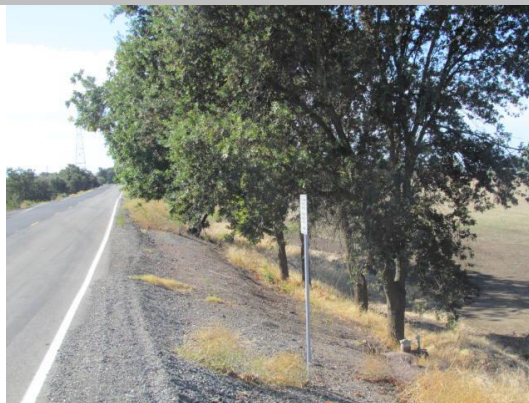
Photo 2 of 2 : SP\_2017\_RD0999\_232\_4\_20170314\_00012.jpg

LM Start	1.73	Rating **	M	Issue No.	4 (cont)	
LM End	1.75	Issue Type +	Ma	Location *	WS	
Category	Earthen Levee			GPS Latitude/Longitude		
				Start		End
Item	Trim / Thin Trees			38.480082 °		38.479788 °
				-121.580930 °		-121.580918 °
DWR ID	DWR_RD0999_01_s_2012_4					
Comment Code						
T1 : Trim trees to at least five feet above ground level.						
Inspector Comment

Looking southwest at trimmed trees on waterward slope.

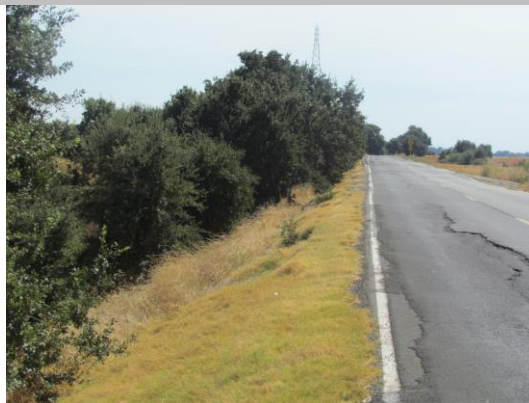
Photo 1 of 2 : SP\_2017\_RD0999\_232\_30\_20170314\_00028.jpg

LM Start	1.79	Rating **	U	Issue No.	30
LM End	2.04	Issue Type +	Ma	Location *	LS
Category	Earthen Levee			GPS Latitude/Longitude	
				Start	End
Item	Trim / Thin Trees			38.479165 °	38.475463 °
				-121.580640 °	-121.580722 °
DWR ID	DWR_RD0999_01_s_2012_30				
Comment Code					
T1 : Trim trees to at least five feet above ground level.					
Inspector Comment

Looking southeast at dense trees on landward slope. (Fall 2016)

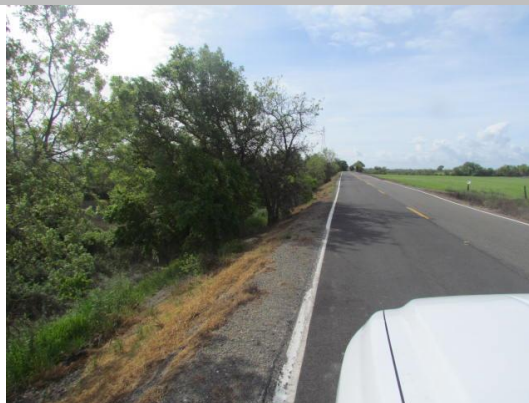
Photo 2 of 2 : SP\_2017\_RD0999\_232\_30\_20170314\_00029.jpg

LM Start	1.79	Rating **	U	Issue No.	30 (cont)	
LM End	2.04	Issue Type +	Ma	Location *	LS	
Category	Earthen Levee			GPS Latitude/Longitude		
				Start		End
Item	Trim / Thin Trees			38.479165 °		38.475463 °
				-121.580640 °		-121.580722 °
DWR ID	DWR_RD0999_01_s_2012_30					
Comment Code						
T1 : Trim trees to at least five feet above ground level.						
Inspector Comment

Looking southeast at dense trees on landward slope. (Spring 2016)

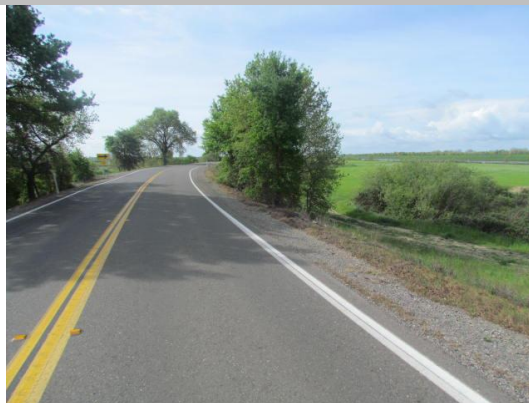
Photo 2 of 2 : SP\_2017\_RD0999\_232\_7\_20170314\_00016.jpg

LM Start	2.13	Rating **	U	Issue No.	7 (cont)	
LM End	2.13	Issue Type +	Ma	Location *	WS	
Category	Earthen Levee			GPS Latitude/Longitude		
				Start		End
Item	Trim / Thin Trees			38.474258 °		38.474258 °
				-121.580528 °		-121.580528 °
DWR ID	DWR_RD0999_01_s_2012_7					
Comment Code						
T1 : Trim trees to at least five feet above ground level.						
Inspector Comment

Looking south at untrimmed trees on waterward slope. (Spring 2016)

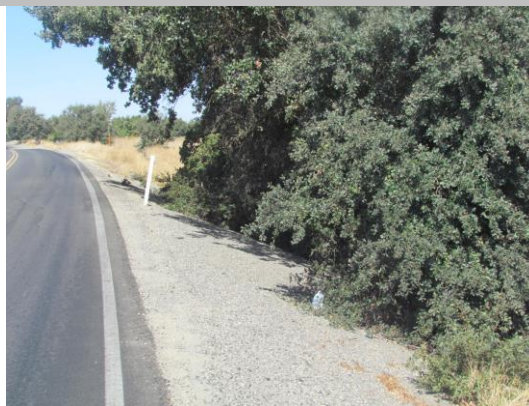
Photo 1 of 2 : SP\_2017\_RD0999\_232\_31\_20170314\_00030.jpg

LM Start	2.13	Rating **	U	Issue No.	31
LM End	2.13	Issue Type +	Ma	Location *	LS
Category	Earthen Levee			GPS Latitude/Longitude	
				Start	End
Item	Trim / Thin Trees			38.474200 °	38.474200 °
				-121.580480 °	-121.580480 °
DWR ID	DWR_RD0999_01_s_2012_31				
Comment Code					
T1 : Trim trees to at least five feet above ground level.					
Inspector Comment

Looking north at untrimmed trees on landward slope. ( Fall 2016)

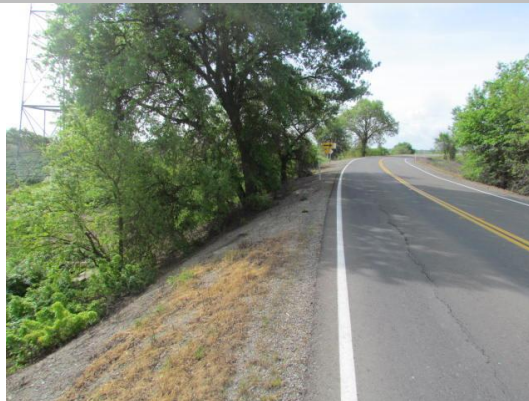
Photo 2 of 2 : SP\_2017\_RD0999\_232\_31\_20170314\_00031.jpg

Looking southeast at untrimmed trees on landward slope. (Spring 2016)

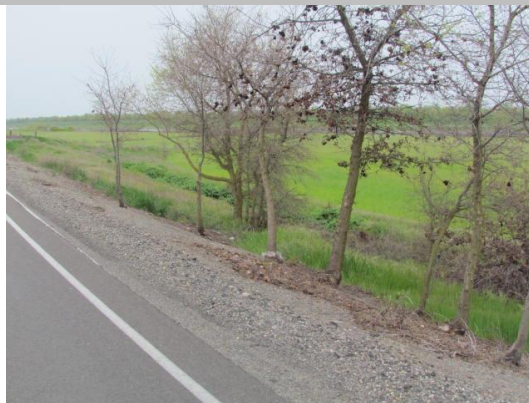
Photo 1 of 1 : SP\_2017\_RD0999\_232\_8\_20170314\_00017.jpg

LM Start	2.18	Rating **	M	Issue No.	8
LM End	2.19	Issue Type +	Ma	Location *	WS
Category	Earthen Levee			GPS Latitude/Longitude	
				Start	End
Item	Trim / Thin Trees			38.473542 °	38.473417 °
				-121.580793 °	-121.580885 °
DWR ID	DWR_RD0999_01_s_2012_8				
Comment Code					
T2 : Thin trees to allow visibility of the ground and room to flood fight.					
Inspector Comment

Looking southwest at trimmed trees on waterside slope. (Spring 2012)

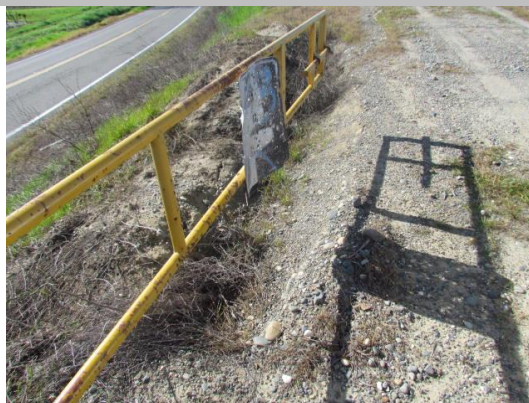
Photo 1 of 4 : SP\_2017\_RD0999\_232\_40\_20170314\_00037.jpg

LM Start	2.51	Rating **	M	Issue No.	40
LM End	2.51	Issue Type +	Ma	Location *	LS
Category	Earthen Levee			GPS Latitude/Longitude	
				Start	End
Item	Encroachments			38.469048 °	38.469048 °
				-121.583075 °	-121.583075 °
DWR ID	DWR_RD0999_01_s_2012_40				
Comment Code					
MA : Material					
Inspector Comment					
Excavation activity on landside shoulder. Hole is approximately 15ft x 12" x 15". Hole appears to be excavated by a backhoe.

Looking south at trench along landward shoulder. (spring 2016)

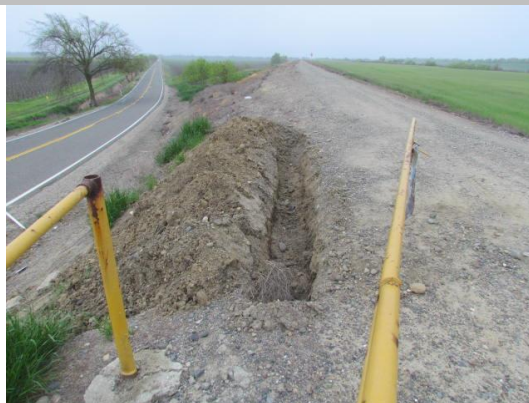
Photo 2 of 4 : SP\_2017\_RD0999\_232\_40\_20170314\_00038.jpg

Looking south at excavation on landside shoulder.

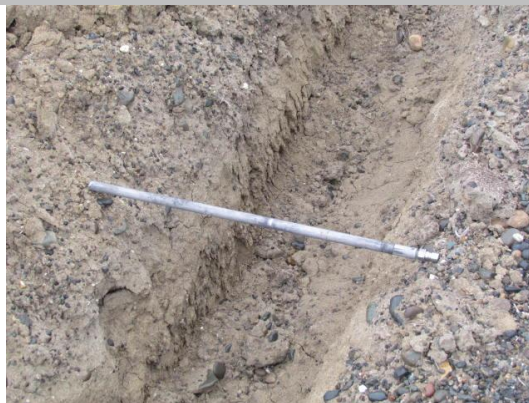
Photo 3 of 4 : SP\_2017\_RD0999\_232\_40\_20170314\_00039.jpg

LM Start	2.51	Rating **	M	Issue No.	40 (cont)	
LM End	2.51	Issue Type +	Ma	Location *	LS	
Category	Earthen Levee			GPS Latitude/Longitude		
				Start		End
Item	Encroachments			38.469048 °		38.469048 °
				-121.583075 °		-121.583075 °
DWR ID	DWR_RD0999_01_s_2012_40					
Comment Code						
MA : Material						
Inspector Comment						
Excavation activity on landside shoulder. Hole is approximately 15ft x 12" x 15". Hole appears to be excavated by a backhoe.

Looking south at close-up view of excavation on landside shoulder.

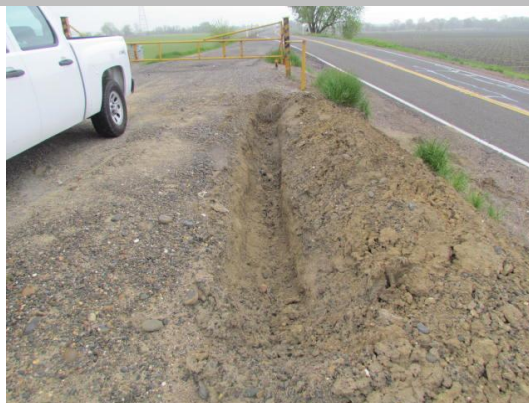
Photo 4 of 4 : SP\_2017\_RD0999\_232\_40\_20170314\_00040.jpg

Looking north at excavation on landside shoulder.

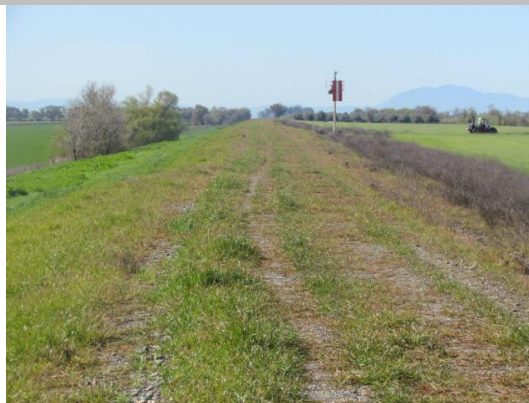
Photo 1 of 1 : SP\_2017\_RD0999\_232\_46\_20170314\_00047.jpg

LM Start	2.53	Rating **	M	Issue No.	46
LM End	4.98	Issue Type +	Ma	Location *	CR
Category	Earthen Levee			GPS Latitude/Longitude	
				Start	End
Item	Crown Surface / Depressions / Rutting			38.468801 °	38.435378 °
				-121.583189 °	-121.598664 °
DWR ID	DWR_RD0999_01_f_2013_46				
Comment Code					
C2 : Repair depressions or ruts in the crown or slope.					
Inspector Comment					
Control growth on levee crown and repair ruts on levee crown. And add appropriate gravel or road base.

Looking south at growth on levee crown.

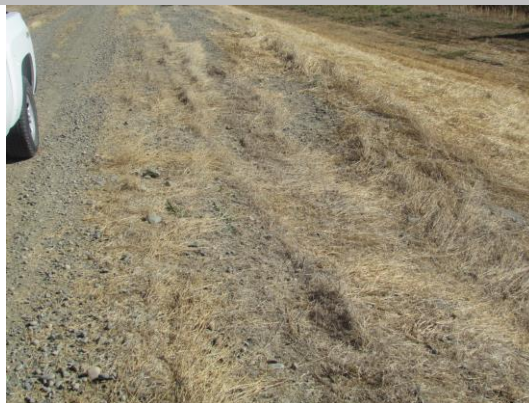
Photo 1 of 2 : SP\_2017\_RD0999\_232\_51\_20170314\_00058.jpg

LM Start	3.22	Rating **	M	Issue No.	51
LM End	3.22	Issue Type +	Ma	Location *	LS
Category	Earthen Levee			GPS Latitude/Longitude	
				Start	End
Item	Slope Stability			38.459399 °	38.459399 °
				-121.587523 °	-121.587523 °
DWR ID	DWR_RD0999_01_s_2013_51				
Comment Code					
S1 : Repair slope instability.					
Inspector Comment					
Depression on landward shoulder and slope 40' x 20'. Earthen material appears to be sliding toward levee toe.

Looking northeast at depression on landward slope. (Fall 2016)

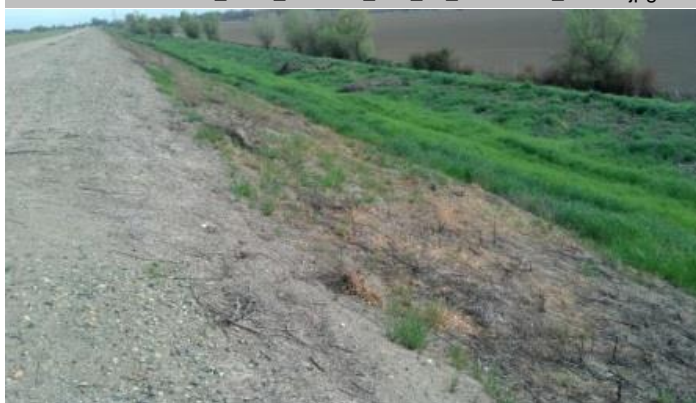
Photo 2 of 2 : SP\_2017\_RD0999\_232\_51\_20170314\_00059.jpg

Looking north at depression on landside shoulder and slope. (Spring 2016)

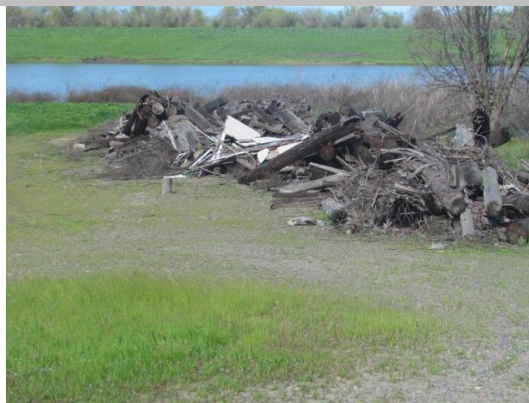
Photo 1 of 3 : SP\_2017\_RD0999\_232\_64\_20170314\_00065.jpg

LM Start	3.30	Rating **	M	Issue No.	64
LM End	3.30	Issue Type +	En	Location *	WS
Category	Earthen Levee			GPS Latitude/Longitude	
				Start	End
Item	Encroachments			38.458346 °	38.458346 °
				-121.588008 °	-121.588008 °
DWR ID	DWR_RD0999_01_s_2014_64				
Comment Code					
TR : Tree or limb					
Inspector Comment					
Discarded tree branches, limbs and power poles stockpile on waterward berm.

Looking west at pruning pile on waterward berm. (spring 2016)

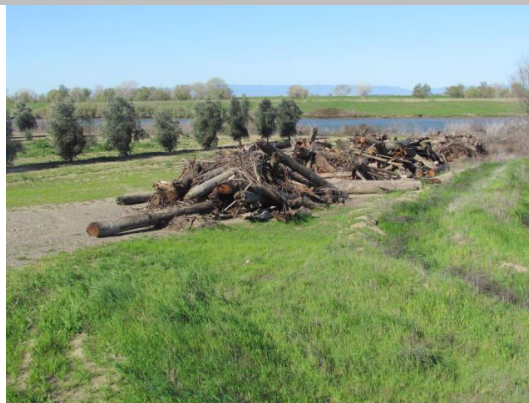
Photo 2 of 3 : SP\_2017\_RD0999\_232\_64\_20170314\_00066.jpg

LM Start	3.30	Rating **	M	Issue No.	64 (cont)	
LM End	3.30	Issue Type +	En	Location *	WS	
Category	Earthen Levee			GPS Latitude/Longitude		
				Start		End
Item	Encroachments			38.458346 °		38.458346 °
				-121.588008 °		-121.588008 °
DWR ID	DWR_RD0999_01_s_2014_64					
Comment Code						
TR : Tree or limb						
Inspector Comment						
Discarded tree branches, limbs and power poles stockpile on waterward berm.

Looking southwest at pruning on waterward berm.

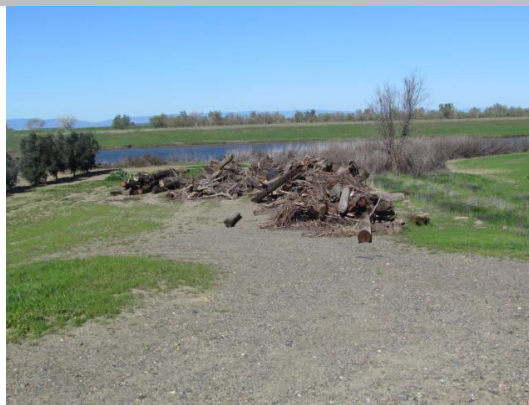
Photo 3 of 3 : SP\_2017\_RD0999\_232\_64\_20170314\_00067.jpg

Looking west at prunings on waterward berm.

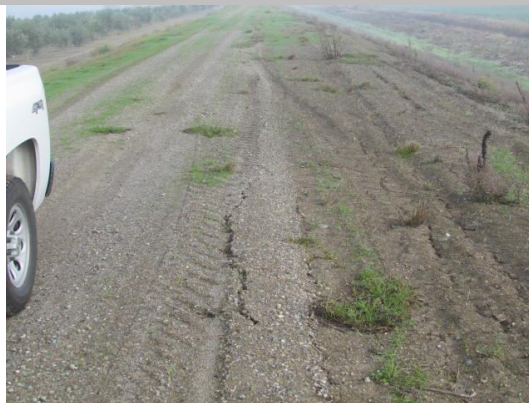
Photo 1 of 3 : SP\_2017\_RD0999\_232\_6\_20170314\_00013.jpg

District Manager (Bob Webber) indicated that the area has a history of cracking and sloughing. District plans to repair site this summer. District repaired site without notifying the Dept. No compaction results provided. Unclear how site was repaired. Need more information about repair from district. During the fall inspection small cracks and sloughing were seen re-appearing on landside shoulder and slope. Spring 2017 inspection additional sloughing has occurred. Area appears to have had raincoat during season. Crown area has a slope instability on landward side.

Looking north at sloughing on landside shoulder and slope.

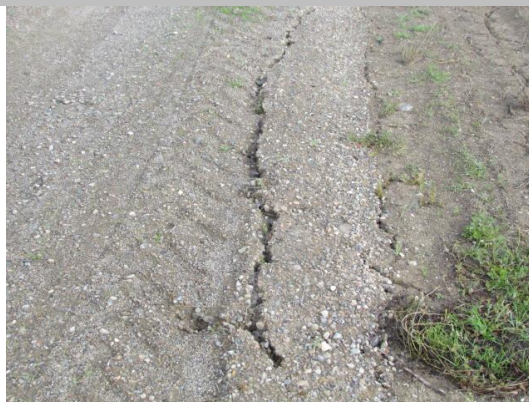
Photo 2 of 3 : SP\_2017\_RD0999\_232\_6\_20170314\_00014.jpg

Looking north at cracking and sloughing on landside shoulder and slope.

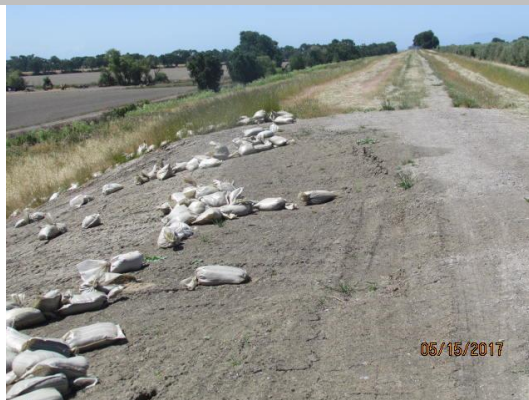
Photo 3 of 3 : SP\_2017\_RD0999\_232\_6\_20170516\_00105.jpg

Comment Code						
S1 : Repair slope instability.						
Inspector Comment						
District Manager (Bob Webber) indicated that the area has a history of cracking and sloughing. District plans to repair site this summer. District repaired site without notifying the Dept. No compaction results provided. Unclear how site was repaired. Need more information about repair from district. During the fall inspection small cracks and sloughing were seen re-appearing on landside shoulder and slope. Spring 2017 inspection additional sloughing has occurred. Area appears to have had raincoat during season. Crown area has a slope instability on landward side.

Looking south at sloughing on landside shoulder and slope (Spring 2017)

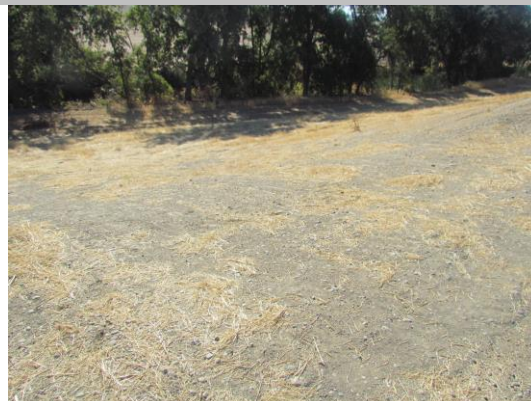
Photo 1 of 2 : SP\_2017\_RD0999\_232\_35\_20170314\_00032.jpg

LM Start	4.31	Rating **	M	Issue No.	35
LM End	4.31	Issue Type +	Ma	Location *	LS
Category	Earthen Levee			GPS Latitude/Longitude	
				Start	End
Item	Slope Stability			38.444561 °	38.444561 °
				-121.594438 °	-121.594438 °
DWR ID	DWR_RD0999_01_f_2012_35				
Comment Code					
S3 : Repair the levee slope damaged by vehicle traffic and prevent access where possible.					
Inspector Comment					
Depression is caused by vehicle traffic.

Looking southeast at slope damage cause by vehicle traffic on landward slope. (Fall 2016)

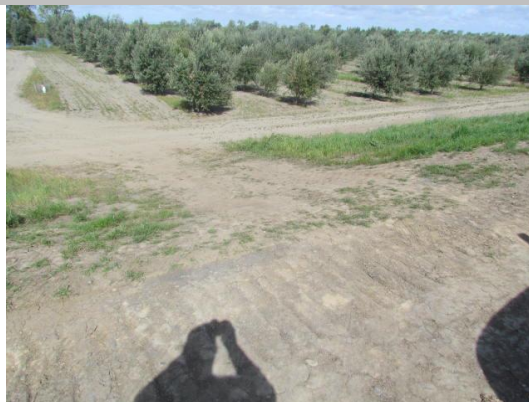
Photo 2 of 2 : SP\_2017\_RD0999\_232\_27\_20170314\_00025.jpg

LM Start	4.31	Rating **	M	Issue No.	27
LM End	4.31	Issue Type +	Ma	Location *	WS
Category	Earthen Levee			GPS Latitude/Longitude	
				Start	End
Item	Slope Stability			38.444560 °	38.444560 °
				-121.594440 °	-121.594440 °
DWR ID	DWR_RD0999_01_f_2012_27				
Comment Code					
S3 : Repair the levee slope damaged by vehicle traffic and prevent access where possible.					
Inspector Comment					
Local farmer causing slope damage by driving equipment and trucks on slope.

Looking at slope damage cause by vehicle traffic on waterward slope. (Spring 2015)

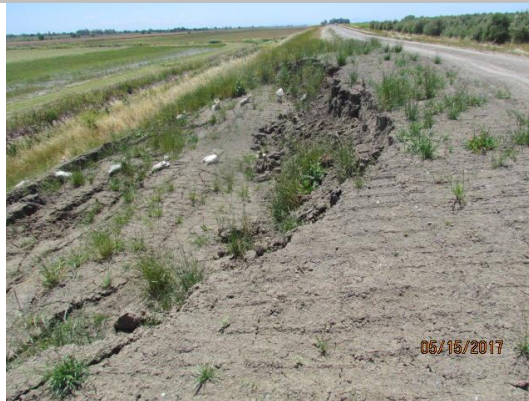
Photo 1 of 1 : SP\_2017\_RD0999\_232\_59\_20170516\_00106.jpg

LM Start	5.19	Rating **	U	Issue No.	59
LM End	5.20	Issue Type +	Ma	Location *	LS
Category	Earthen Levee			GPS Latitude/Longitude	
				Start	End
Item	Erosion / Bank Caving			38.432548 °	38.432434 °
				-121.600031 °	-121.600085 °
DWR ID	DWR_RD0999_01_s_2017_59				
Comment Code					
E2 : Schedule repair of erosion site prior to the next inspection.					
Inspector Comment					
Appears to be a rotational slip on landside.

View of rotation slip looking south (Spring 2017)

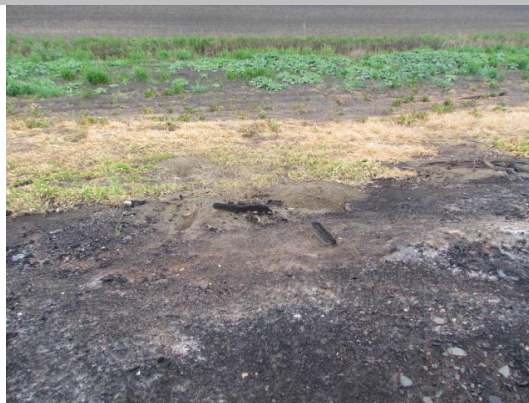
Photo 1 of 2 : SP\_2017\_RD0999\_232\_42\_20170314\_00043.jpg

LM Start	6.56	Rating **	M	Issue No.	42
LM End	6.56	Issue Type +	Ma	Location *	LS
Category	Earthen Levee			GPS Latitude/Longitude	
				Start	End
Item	Animal Control			38.413858 °	38.413858 °
				-121.608638 °	-121.608638 °
DWR ID	DWR_RD0999_01_s_2012_42				
Comment Code					
A1 : Exterminate rodents and backfill and compact or grout burrows.					
Inspector Comment					
More than five holes within 25' of levee.

Looking east at rodent holes on landside slope.

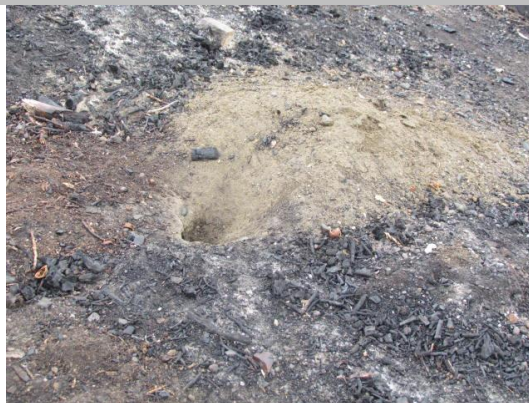
Photo 2 of 2 : SP\_2017\_RD0999\_232\_42\_20170314\_00044.jpg

LM Start	6.56	Rating **	M	Issue No.	42 (cont)	
LM End	6.56	Issue Type +	Ma	Location *	LS	
Category	Earthen Levee			GPS Latitude/Longitude		
				Start		End
Item	Animal Control			38.413858 °	38.413858 °	
				-121.608638 °	-121.608638 °	
DWR ID	DWR_RD0999_01_s_2012_42					
Comment Code						
A1 : Exterminate rodents and backfill and compact or grout burrows.						
Inspector Comment						
More than five holes within 25' of levee.

Looking at typical rodent hole on landside slope.

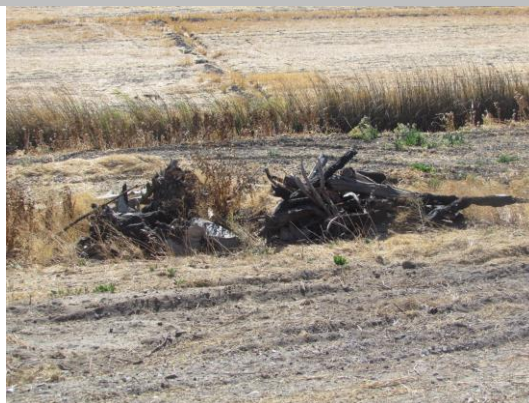
Photo 1 of 2 : SP\_2017\_RD0999\_232\_41\_20170314\_00041.jpg

LM Start	6.56	Rating **	M	Issue No.	41
LM End	6.59	Issue Type +	Ma	Location *	LS
Category	Earthen Levee			GPS Latitude/Longitude	
				Start	End
Item	Encroachments			38.413856 °	38.413475 °
				-121.608635 °	-121.608817 °
DWR ID	DWR_RD0999_01_s_2016_41				
Comment Code					
PR : Prunings					
Inspector Comment					
Pruning piles on landward toe.

Looking east at prunings at landward toe and berm. (Fall 2016)

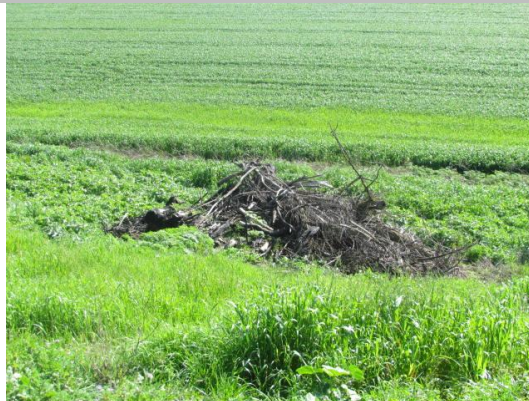
Photo 2 of 2 : SP\_2017\_RD0999\_232\_41\_20170314\_00042.jpg

Looking east at prunings on landward toe and berm. (Spring 2016)

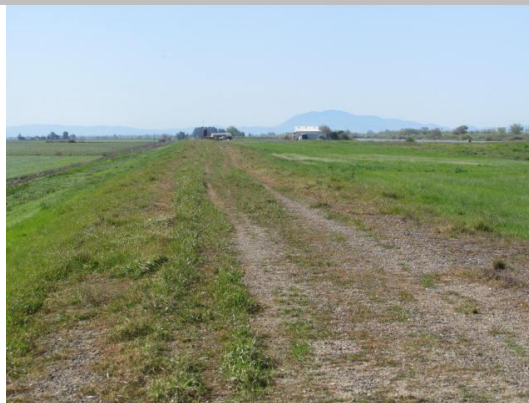
Photo 1 of 2 : SP\_2017\_RD0999\_232\_22\_20170314\_00019.jpg

LM Start	6.77	Rating **	M	Issue No.	22
LM End	9.67	Issue Type +	Ma	Location *	CR
Category	Earthen Levee			GPS Latitude/Longitude	
				Start	End
Item	Crown Surface / Depressions / Rutting			38.411031 °	38.371621 °
				-121.609960 °	-121.628232 °
DWR ID	DWR_RD0999_01_s_2012_22				
Comment Code					
C3 : Add appropriate gravel or road base. Grade and compact.					
Inspector Comment					
Also control growth on levee crown.

Looking south at levee crown. (Spring 2016)

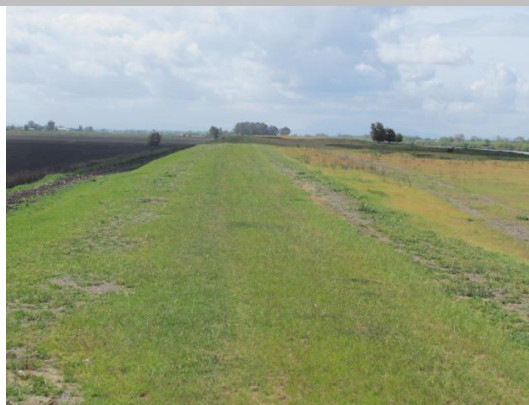
Photo 2 of 2 : SP\_2017\_RD0999\_232\_22\_20170314\_00020.jpg

Looking south at levee crown. (Spring 2015)

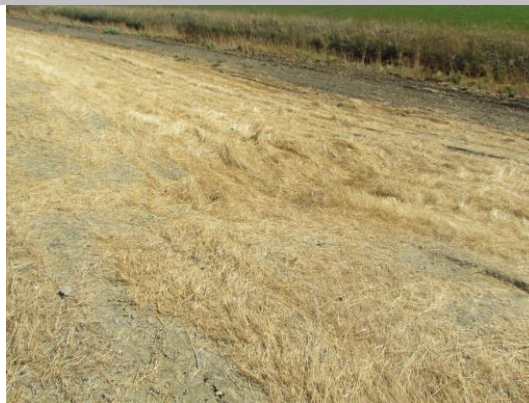
Photo 1 of 2 : SP\_2017\_RD0999\_232\_58\_20170314\_00062.jpg

LM Start	7.61	Rating **	U	Issue No.	58
LM End	7.61	Issue Type +	Ma	Location *	LS
Category	Earthen Levee			GPS Latitude/Longitude	
				Start	End
Item	Erosion / Bank Caving			38.399600 °	38.399600 °
				-121.615224 °	-121.615224 °
DWR ID	DWR_RD0999_01_f_2016_58				
Comment Code					
Inspector Comment					
Depression 10' by 20' on landward slope.

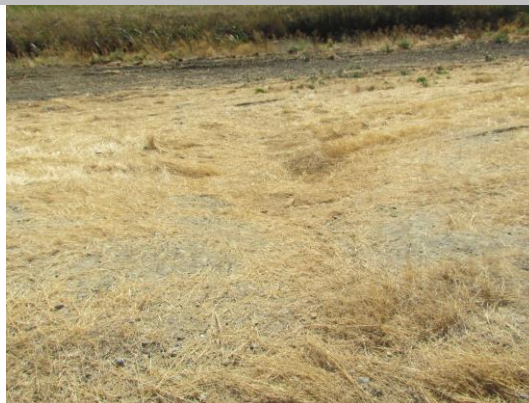
Photo 2 of 2 : SP\_2017\_RD0999\_232\_58\_20170314\_00063.jpg

LM Start	7.61	Rating **	U	Issue No.	58 (cont)	
LM End	7.61	Issue Type +	Ma	Location *	LS	
Category	Earthen Levee			GPS Latitude/Longitude		
				Start		End
Item	Erosion / Bank Caving			38.399600 °	38.399600 °	
				-121.615224 °	-121.615224 °	
DWR ID	DWR_RD0999_01_f_2016_58					
Comment Code						
Inspector Comment						
Depression 10' by 20' on landward slope.

Looking northeast at depression on landward slope.

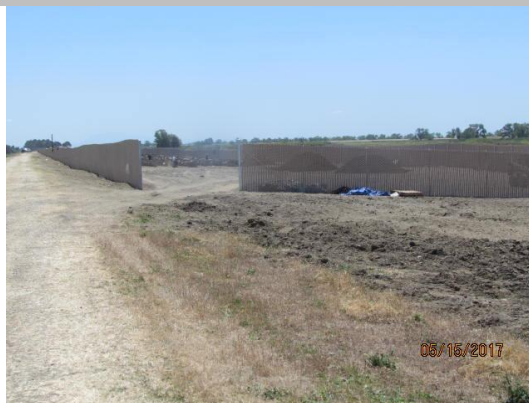
Photo 1 of 2 : SP\_2017\_RD0999\_232\_60\_20170516\_00108.jpg

LM Start	8.24	Rating **	M	Issue No.	60
LM End	8.57	Issue Type +	En	Location *	WS
Category	Earthen Levee			GPS Latitude/Longitude	
				Start	End
Item	Encroachments			38.391062 °	38.386568 °
				-121.619210 °	-121.621360 °
DWR ID	DWR_RD0999_01_s_2017_60				
Comment Code					
FE : Fence					
Inspector Comment

Looking south at new fence construction on waterside (Spring 2017)

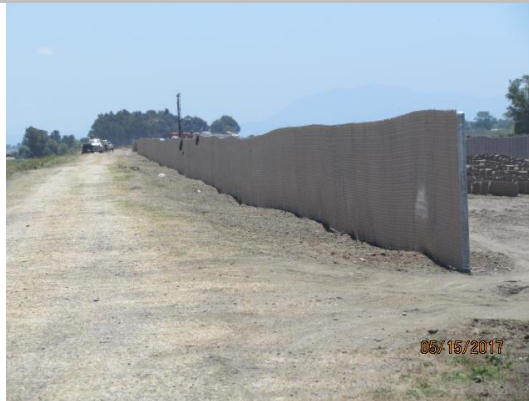
Photo 2 of 2 : SP\_2017\_RD0999\_232\_60\_20170516\_00109.jpg

LM Start	<b>8.24</b>	Rating **	M	Issue No.	<b>60 (cont)</b>
LM End	<b>8.57</b>	Issue Type +	En	Location *	WS

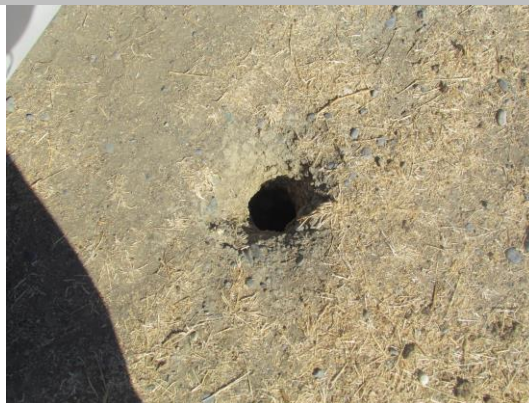
Photo 2 of 3 : SP\_2017\_RD0999\_232\_69\_20170314\_00075.jpg

LM Start	9.34	Rating **	M	Issue No.	69 (cont)	
LM End	9.34	Issue Type +	Ma	Location *	CR	
Category	Earthen Levee			GPS Latitude/Longitude		
				Start		End
Item	Animal Control			38.376094 °		38.376094 °
				-121.626178 °		-121.626178 °
DWR ID	DWR_RD0999_01_s_2016_69					
Comment Code						
A1 : Exterminate rodents and backfill and compact or grout burrows.						
Inspector Comment						
Rodent holes noted on levee crown, shoulder and landward slope

Looking at typical rodent hole on landward shoulder. (Fall 2016)

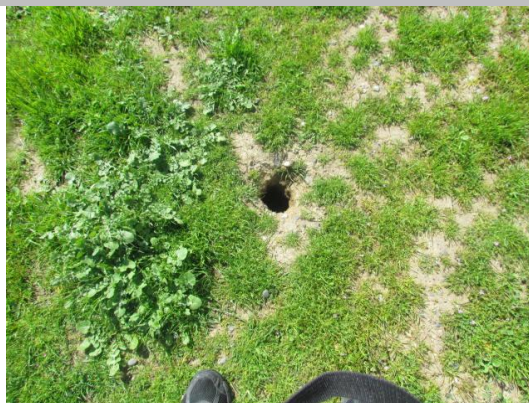
Photo 3 of 3 : SP\_2017\_RD0999\_232\_69\_20170314\_00076.jpg

Looking at typical rodent hole on levee crown and slope. (Spring 2016)

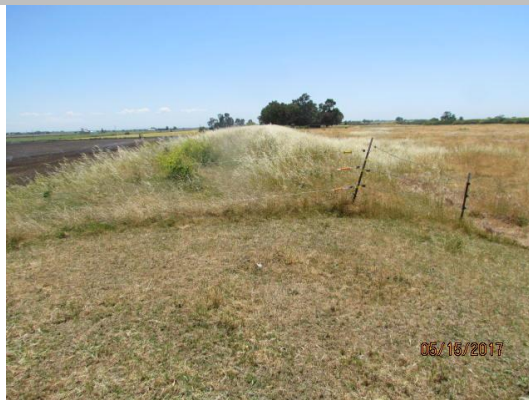
Photo 1 of 1 : SP\_2017\_RD0999\_232\_63\_20170516\_00110.jpg

LM Start	9.50	Rating **	U	Issue No.	63
LM End	9.50	Issue Type +	En	Location *	CR
Category	Earthen Levee			GPS Latitude/Longitude	
				Start	End
Item	Encroachments			38.373911 °	38.373911 °
				-121.627161 °	-121.627161 °
DWR ID	DWR_RD0999_01_s_2017_63				
Comment Code					
FE : Fence					
Inspector Comment					
Inaccessible

View of fence (Spring 2017)

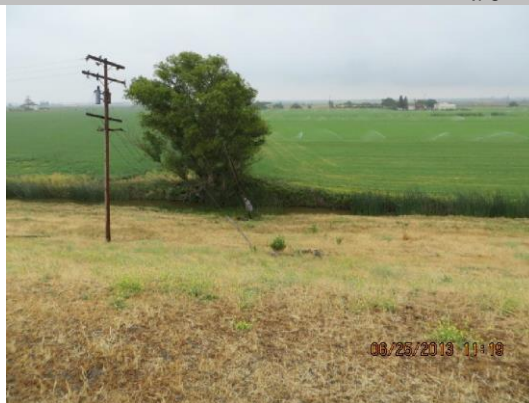
Photo 1 of 3 : UCIP\_SP\_2017\_24413\_43357.jpg

LM Start	9.50	Rating **	M	Issue No.	921
LM End	9.50	Issue Type +	En	Location *	CR
Category	Supplemental			GPS Latitude/Longitude	
				Start	End
Item	DWR UCIP Field Study			38.373823 °	38.373823 °
				-121.627212 °	-121.627212 °
DWR ID					
Comment Code					
Inspector Comment					
FS_ID:24413 DS_ID:22750 EP_NO: 13300 Repair Type: Non-Urgent Crossing Status: Found UCIP Comments: Pipe abandoned and should be done so properly. FIELD_STRUCT_DESC: 6-inch steel pipe through the levee 3.0 feet below the crown. JP and meter at abandoned pump location on LS toe (Permit No. 13300, 1983). FS Date: 6/25/2013

JP and meter at site of abandoned pump.

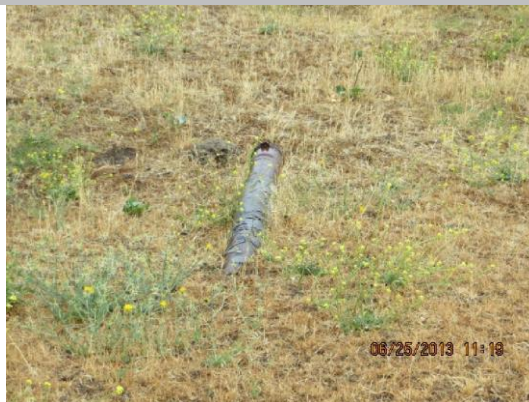
Photo 2 of 3 : UCIP\_SP\_2017\_24413\_43356.jpg

Pipe open on WS slope.

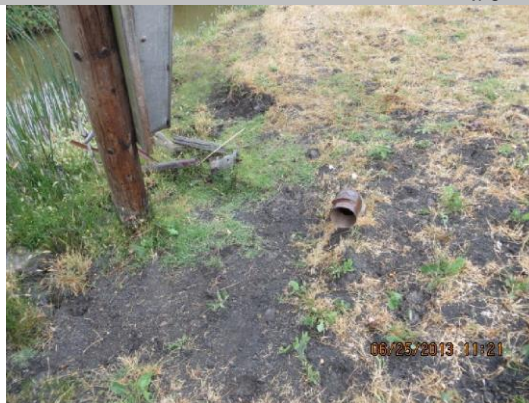
Photo 3 of 3 : UCIP\_SP\_2017\_24413\_43355.jpg

LM Start	9.50	Rating **	M	Issue No.	921 (cont)
LM End	9.50	Issue Type +	En	Location *	CR
Category	Supplemental			GPS Latitude/Longitude	
				Start	End
Item	DWR UCIP Field Study			38.373823 °	38.373823 °
				-121.627212 °	-121.627212 °
DWR ID					
Comment Code					
Inspector Comment					
FS_ID:24413 DS_ID:22750 EP_NO: 13300 Repair Type: Non-Urgent Crossing Status: Found UCIP Comments: Pipe abandoned and should be done so properly. FIELD_STRUCT_DESC: 6-inch steel pipe through the levee 3.0 feet below the crown. JP and meter at abandoned pump location on LS toe (Permit No. 13300, 1983). FS Date: 6/25/2013

JP and meter at site of abandoned pump.

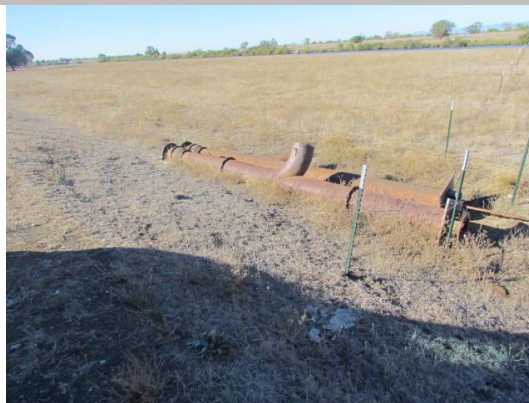
Photo 1 of 1 : SP\_2017\_RD0999\_232\_47\_20170314\_00048.jpg

LM Start	9.51	Rating **	M	Issue No.	47
LM End	9.51	Issue Type +	Ma	Location *	WS
Category	Earthen Levee			GPS Latitude/Longitude	
				Start	End
Item	Encroachments			38.373740 °	38.373740 °
				-121.627257 °	-121.627257 °
DWR ID	DWR_RD0999_01_f_2015_47				
Comment Code					
PI : Pipe					
Inspector Comment					
Abandoned pipes at waterward toe.

Looking southwest at abandoned irrigation pipes at waterward toe.

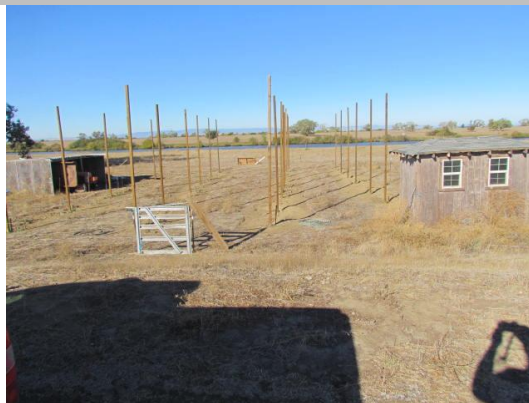
Photo 1 of 1 : SP\_2017\_RD0999\_232\_56\_20170314\_00060.jpg

LM Start	9.64	Rating **	M	Issue No.	56
LM End	9.64	Issue Type +	En	Location *	WS
Category	Earthen Levee			GPS Latitude/Longitude	
				Start	End
Item	Encroachments			38.372002 °	38.372002 °
				-121.628052 °	-121.628052 °
DWR ID	DWR_RD0999_01_f_2015_56				
Comment Code					
CR : Crops					
Inspector Comment					
Landowner planted crops and installed poles and tool sheds on waterward berm without permit

Looking at west at crop, poles and tool sheds on waterward berm.

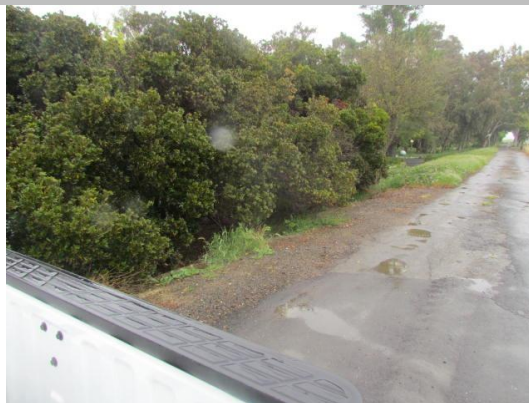
Photo 1 of 1 : SP\_2017\_RD0999\_232\_26\_20170314\_00023.jpg

LM Start	9.87	Rating **	M	Issue No.	26
LM End	9.87	Issue Type +	En	Location *	WS
Category	Earthen Levee			GPS Latitude/Longitude	
				Start	End
Item	Vegetation			38.368898 °	38.368898 °
				-121.629470 °	-121.629470 °
DWR ID	DWR_RD0999_01_s_2012_26				
Comment Code					
V6 : Landscaping					
Inspector Comment					
Trees should be trimmed for visibility.

Looking northwest at dense trees on waterside slope.

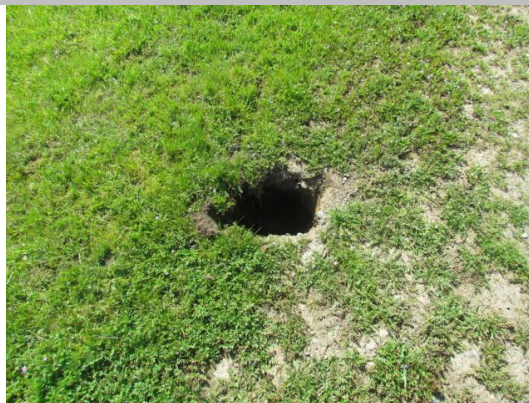
Photo 1 of 5 : SP\_2017\_RD0999\_232\_2\_20170314\_00006.jpg

LM Start	<b>9.95</b>	Rating **	U	Issue No.	<b>2 (cont)</b>
LM End	<b>9.95</b>	Issue Type +	Ma	Location *	LS

Looking southeast at large rodent hole on landward shoulder. (Spring 2016)

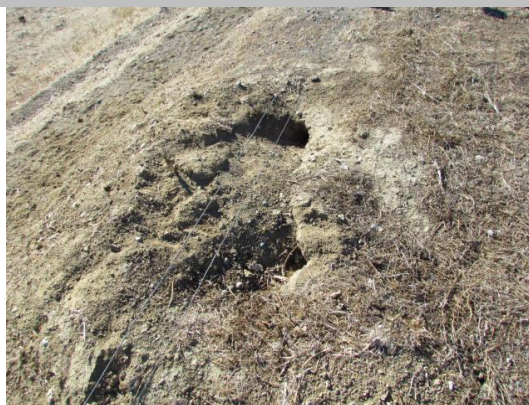
Photo 2 of 5 : SP\_2017\_RD0999\_232\_2\_20170314\_00007.jpg

Looking southeast at rodent holes on landward shoulder fall 2015.

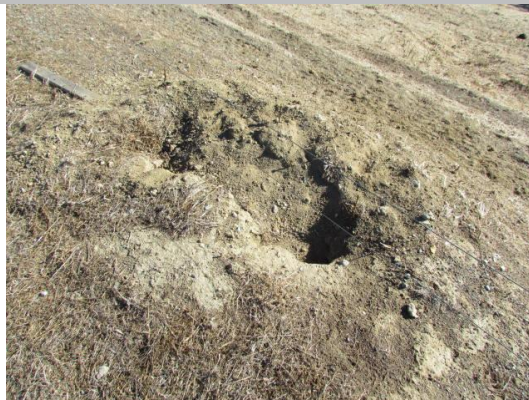
Photo 3 of 5 : SP\_2017\_RD0999\_232\_2\_20170314\_00008.jpg

Looking northeast at rodent holes on landward shoulder fall 2015.

LM Start	<b>9.95</b>	Rating **	U	Issue No.	<b>2 (cont)</b>
LM End	<b>9.95</b>	Issue Type +	Ma	Location *	LS

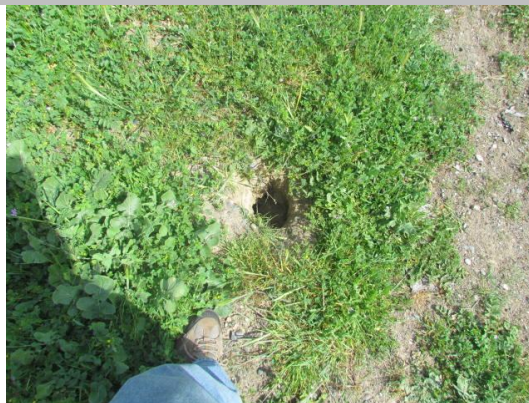
Photo 4 of 5 : SP\_2017\_RD0999\_232\_2\_20170314\_00009.jpg

LM Start	<b>9.95</b>	Rating **	U	Issue No.	<b>2 (cont)</b>
LM End	<b>9.95</b>	Issue Type +	Ma	Location *	LS

Looking at typical rodent holes on landward shoulder. (Spring 2015)

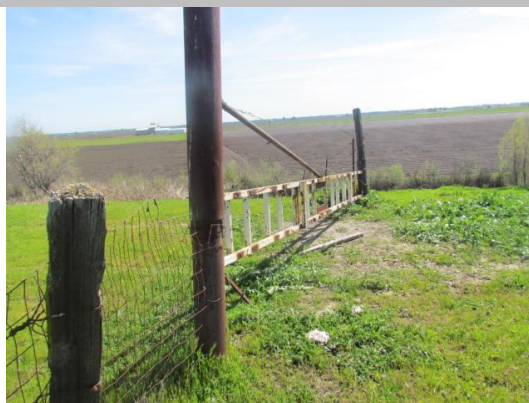
Photo 1 of 4 : SP\_2017\_RD0999\_232\_70\_20170314\_00077.jpg

LM Start	10.21	Rating **	M	Issue No.	70
LM End	10.21	Issue Type +	Ma	Location *	CR
Category	Earthen Levee			GPS Latitude/Longitude	
				Start	End
Item	Repair Gates			38.364229 °	38.364229 °
				-121.631673 °	-121.631673 °
DWR ID	DWR_RD0999_01_s_2016_70				
Comment Code					
Inspector Comment					
Gate drags difficult to open and close. Gate pole leaning.

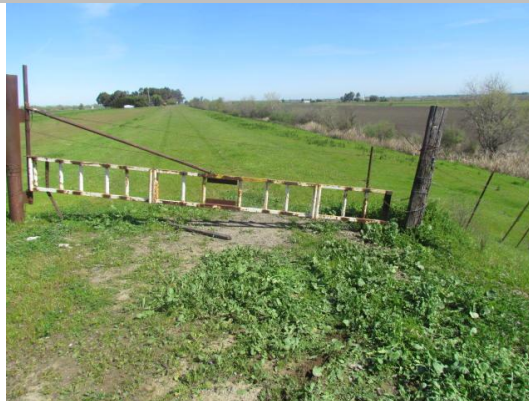
Photo 2 of 4 : SP\_2017\_RD0999\_232\_70\_20170314\_00078.jpg

LM Start	10.21	Rating **	M	Issue No.	70 (cont)	
LM End	10.21	Issue Type +	Ma	Location *	CR	
Category	Earthen Levee			GPS Latitude/Longitude		
				Start		End
Item	Repair Gates			38.364229 °		38.364229 °
				-121.631673 °		-121.631673 °
DWR ID	DWR_RD0999_01_s_2016_70					
Comment Code						
Inspector Comment						
Gate drags difficult to open and close. Gate pole leaning.

Looking south at fence pole.

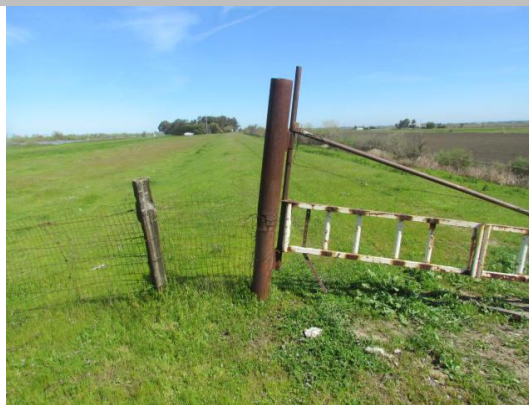
Photo 3 of 4 : SP\_2017\_RD0999\_232\_70\_20170314\_00079.jpg

LM Start	10.21	Rating **	M	Issue No.	70 (cont)
LM End	10.21	Issue Type +	Ma	Location *	CR

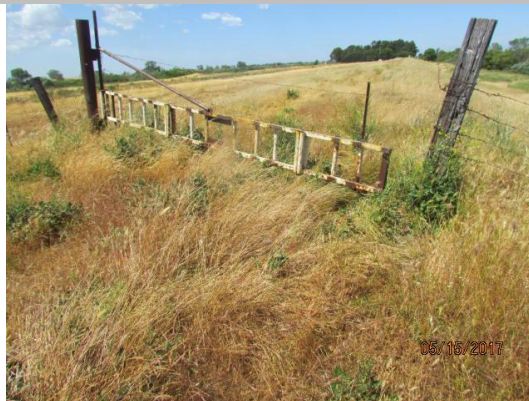
Photo 4 of 4 : SP\_2017\_RD0999\_232\_70\_20170516\_00111.jpg

LM Start	10.21	Rating **	M	Issue No.	70 (cont)
LM End	10.21	Issue Type +	Ma	Location *	CR

Gate was difficult to open (Spring 2017)

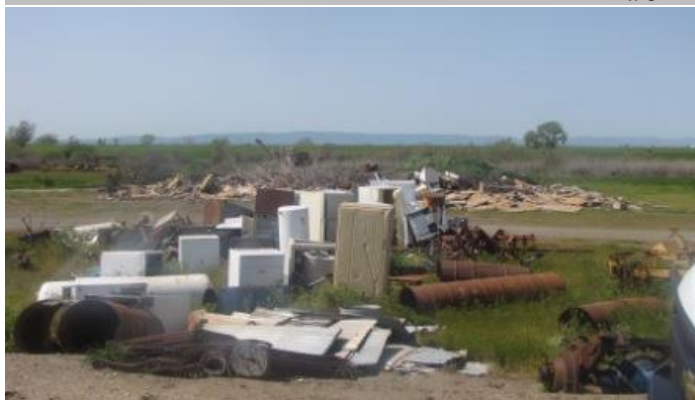
Photo 2 of 2 : SP\_2017\_RD0999\_232\_28\_20170314\_00027.jpg

LM Start	10.57	Rating **	M	Issue No.	28 (cont)	
LM End	10.57	Issue Type +	En	Location *	WS	
Category	Earthen Levee			GPS Latitude/Longitude		
				Start		End
Item	Encroachments			38.359305 °		38.359305 °
				-121.633949 °		-121.633949 °
DWR ID	DWR_RD0999_01_s_2012_28					
Comment Code						
GA : Garbage						
Inspector Comment						
Large garbage and pruning piles on waterward berm.

Looking southwest at garbage on waterside toe and berm.

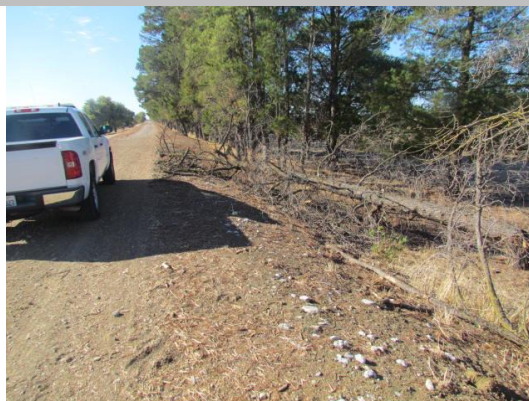
Photo 1 of 2 : SP\_2017\_RD0999\_232\_61\_20170314\_00064.jpg

LM Start	10.75	Rating **	M	Issue No.	61
LM End	10.75	Issue Type +	Ma	Location *	WS
Category	Earthen Levee			GPS Latitude/Longitude	
				Start	End
Item	Encroachments			38.356844 °	38.356844 °
				-121.635101 °	-121.635101 °
DWR ID	DWR_RD0999_01_f_2014_61				
Comment Code					
TR : Tree or limb					
Inspector Comment					
Downed tree on waterward slope

Looking southwest at downed tree on waterward slope.

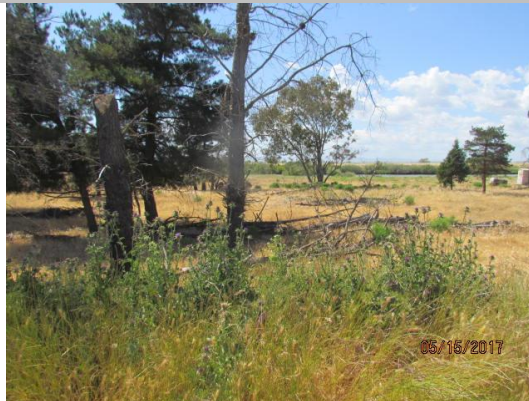
Photo 2 of 2 : SP\_2017\_RD0999\_232\_61\_20170516\_00112.jpg

LM Start	<b>10.75</b>	Rating **	M	Issue No.	<b>61 (cont)</b>
LM End	<b>10.75</b>	Issue Type +	Ma	Location *	WS

Looking northwest at downed tree on waterside slope (Spring 2017)

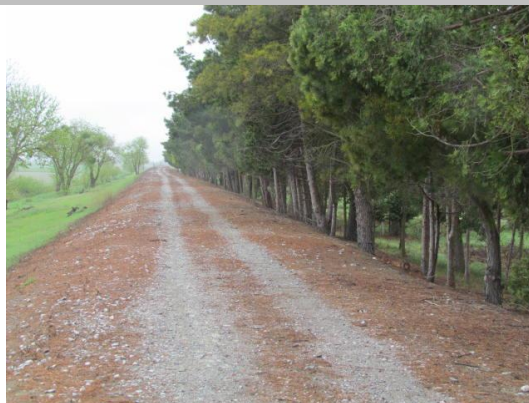
Photo 1 of 2 : SP\_2017\_RD0999\_232\_23\_20170314\_00021.jpg

LM Start	10.81	Rating **	M	Issue No.	23
LM End	11.06	Issue Type +	Ma	Location *	WS
Category	Earthen Levee			GPS Latitude/Longitude	
				Start	End
Item	Trim / Thin Trees			38.356077 °	38.352640 °
				-121.635598 °	-121.637078 °
DWR ID	DWR_RD0999_01_s_2012_23				
Comment Code					
T1 : Trim trees to at least five feet above ground level.					
Inspector Comment

Looking south at trimmed pine trees on waterside shoulder and slope. (Spring 2012)

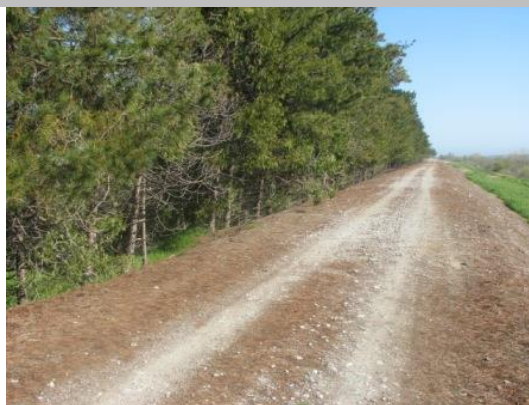
Photo 2 of 2 : SP\_2017\_RD0999\_232\_23\_20170314\_00022.jpg

LM Start	<b>10.81</b>	Rating **	M	Issue No.	<b>23 (cont)</b>
LM End	<b>11.06</b>	Issue Type +	Ma	Location *	WS

Pine trees along waterside shoulder &amp; slope. (Site of a old christmas tree farm). (Spring 2011)

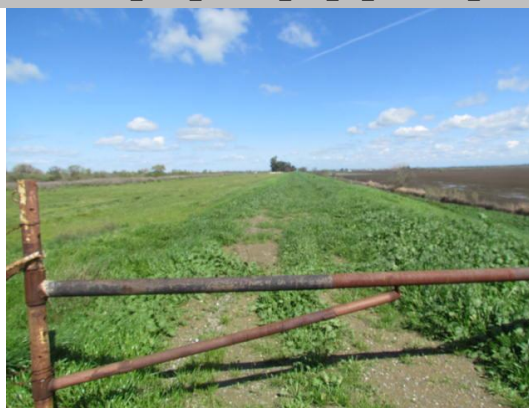
Photo 1 of 1 : SP\_2017\_RD0999\_232\_43\_20170314\_00045.jpg

LM Start	11.30	Rating **	M	Issue No.	43
LM End	11.66	Issue Type +	Ma	Location *	CR
Category	Earthen Levee			GPS Latitude/Longitude	
				Start	End
Item	Crown Surface / Depressions / Rutting			38.349380 °	38.344455 °
				-121.638540 °	-121.640845 °
DWR ID	DWR_RD0999_01_s_2012_43				
Comment Code					
C3 : Add appropriate gravel or road base. Grade and compact.					
Inspector Comment

Looking north at growth on levee crown.

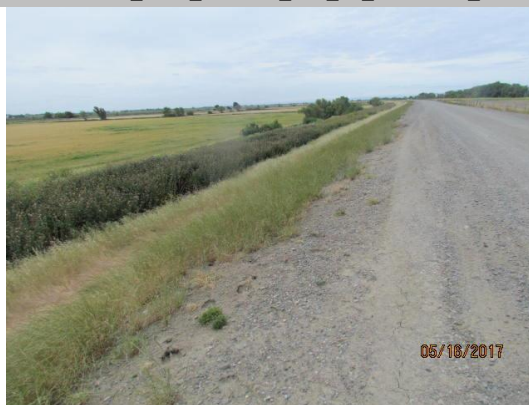
Photo 1 of 1 : SP\_2017\_RD0999\_232\_36\_20170516\_00113.jpg

LM Start	11.63	Rating **	U	Issue No.	36
LM End	12.04	Issue Type +	Ma	Location *	LS
Category	Earthen Levee			GPS Latitude/Longitude	
				Start	End
Item	Vegetation			38.344815 °	38.339193 °
				-121.640697 °	-121.643017 °
DWR ID	DWR_RD0999_01_s_2017_36				
Comment Code					
V2 : Remove the wild growth other than native grasses from the levee slopes.					
Inspector Comment					
Dense weeds at landward toe.

Dense vegetation at landside levee toe.

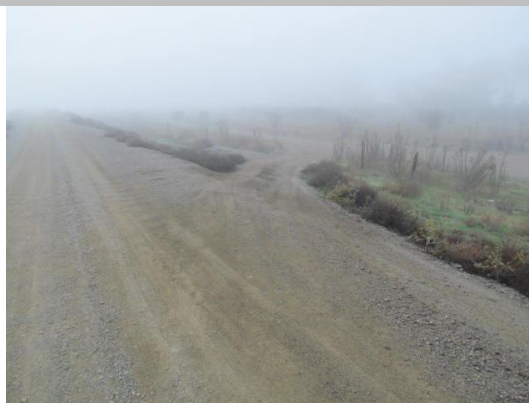
Photo 2 of 2 : SP\_2017\_RD0999\_232\_48\_20170314\_00050.jpg

LM Start	11.84	Rating **	M	Issue No.	48
LM End	11.84	Issue Type +	Ma	Location *	WS
Category	Earthen Levee			GPS Latitude/Longitude	
				Start	End
Item	Slope Stability			38.342068 °	38.342068 °
				-121.641944 °	-121.641944 °
DWR ID	DWR_RD0999_01_f_2012_48				
Comment Code					
S3 : Repair the levee slope damaged by vehicle traffic and prevent access where possible.					
Inspector Comment					
Slope damage caused by vehicle traffic.

Looking southwest at slope damage caused by vehicle traffic on waterside slope.

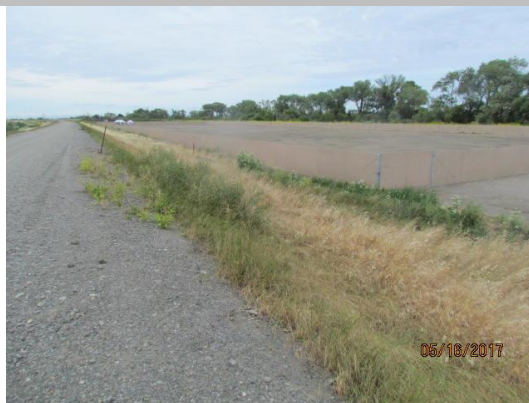
Photo 1 of 2 : SP\_2017\_RD0999\_232\_74\_20170516\_00114.jpg

LM Start	12.04	Rating **	M	Issue No.	74
LM End	12.20	Issue Type +	En	Location *	WS
Category	Earthen Levee			GPS Latitude/Longitude	
				Start	End
Item	Encroachments			38.339217 °	38.336962 °
				-121.642996 °	-121.643688 °
DWR ID	DWR_RD0999_01_s_2017_74				
Comment Code					
FE : Fence					
Inspector Comment					
New fence on waterside berm. Fence is out approximately 20 feet from toe of levee. A well is installed inside the fenced area.

New fence looking southwest (Spring 2017)

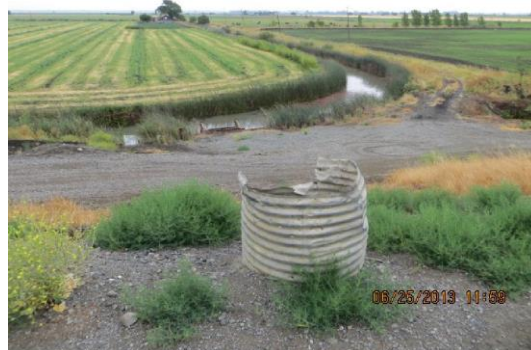
Photo 2 of 3 : UCIP\_SP\_2017\_50097\_25414.jpg

Comment Code					
Inspector Comment					
FS_ID:50097 DS_ID:22752 EP_NO: 11735 Repair Type: Urgent Crossing Status: Found UCIP Comments: 07/07/2016 - Appears abandoned. Pipe is visible in exposed cut on the WS slope of the levee. Riser on LS shoulder damaged from vandalism. welded plate on WS. No pump found on the platform in the drainage ditch. (T. Hatch/UCIP)06/25/2013 - Appears abandoned. Pipe exposed in cut on on WS slope and open at LS toe. No pump or appurtenances. (W. Wylie/UCIP) FIELD_STRUCT_DESC: *ABANDONED* 24-inch steel drainage pipe through the levee, 7 feet below the crown. Pump in a drainage ditch on the landside (LS) with a sheetpile headwall, not found. A flap gate is located on the waterside (WS), not found. Siphon breaker in a riser on the LS slope (Permit No. 11735, 1978 - RD0999). Replaced an existing pipe. [Additional Reference(s): DWR Levee Logs, 1992]. FS Date: 7/7/2016

Siphon breaker in CMP riser on LS shoulder.
